Project Summary

Asadabad 700 kW Hydropower Project in Kunar Province, Aghanistan

Reactivating Asadabad 700kW Hydropower project

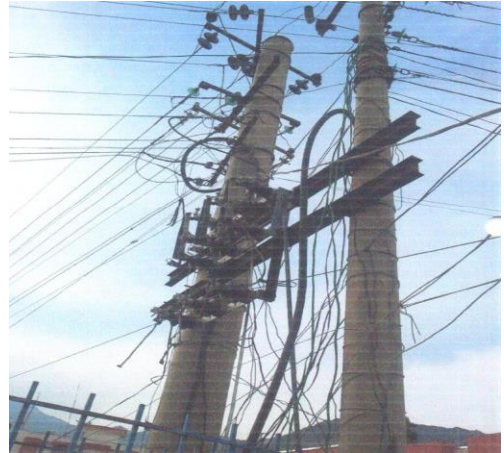
- The automatic hydro mechanical governor for controlling the water flow was destroyed. Only, with hands it could be controlled.
- For stopping the machine there wasn't any automatic system and a long wood used for this purpose.
- There were no defence system for over current, overloading, and over voltage situations.
- The transmission and distribution systems were not standard. In most cases, the lines were merged together. The transmission poles were also at risk of falling down.
- The two generators operated separately. One, provided the load around the power house without using transformer, and the other generated electricity and transmitting this using 0.4:20 Transformer to 10 km distance.

- The diversion weir parts should be reconstructed. Moreover, 15 to 20 cm of RCC layer should be built in order to make enough water flow inside the canal, and also prevent it from destruction in the future.
- The diversion weir and intake parts should be cleaned from sediments and boulders so that enough water could enter the canal.
- New and suitable trash rack should be installed in order to make sure that large stones and boulders don't enter the canal.
- The control gates should be replaced.
- The canal that contains 40-70 cm of sediments and boulders should be cleaned.
- Some parts of the canal should be reconstructed.
- MS or Concrete penstock should be installed.
- The current cross flow turbines should be replaced with Kaplan turbines (each 450kW).
- Current generators should be replaced with synchronous generators (450kW/562 kVA).
