Project Summary

Asadabad 700 kW Hydropower Project in Kunar Province, Aghanistan

Reactivating Asadabad 700kW Hydropower project

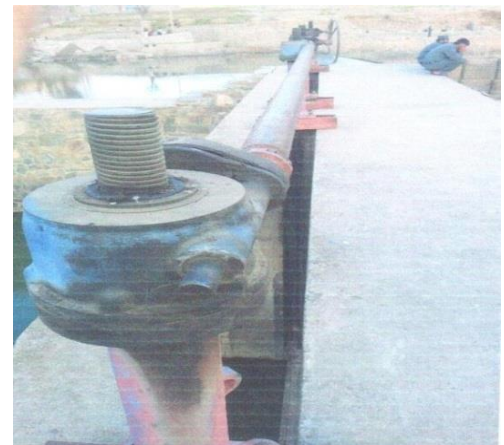
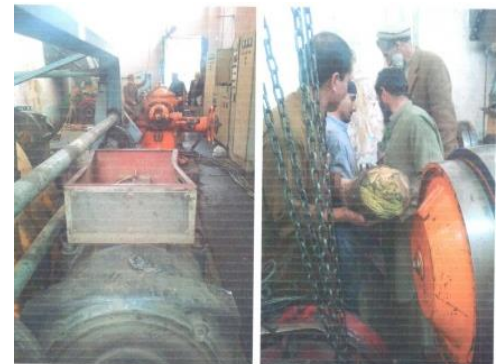
- Some parts of the diversion weir and intake are destroyed. Therefore, enough water couldn't enter the canal at the time of dehydration and water is wasted.
- Sediments and boulders were entered and existed in the canal.
- Trash racks are installed in a way that's difficult to clean it normally.
- Some parts of canal were destroyed and needed reconstruction.
- Sediments were gathered in Forebay, making the water difficult to be filtered.
- The station is without a penstock pipe and the water is entering the power house through an open air structure.
- Inside the powerhouse, there are two cross flow turbines, each capacity is 350kW and they have been active for 31 years without any maintenance work.

- The diversion weir parts should be reconstructed. Moreover, 15 to 20 cm of RCC layer should be built in order to make enough water flow inside the canal, and also prevent it from destruction in the future.
- The diversion weir and intake parts should be cleaned from sediments and boulders so that enough water could enter the canal.
- New and suitable trash rack should be installed in order to make sure that large stones and boulders don't enter the canal.
- The control gates should be replaced.
- The canal that contains 40-70 cm of sediments and boulders should be cleaned.
- Some parts of the canal should be reconstructed.
- MS or Concrete penstock should be installed.
- The current cross flow turbines should be replaced with Kaplan turbines (each 450kW).
- Current generators should be replaced with synchronous generators (450kW/562 kVA).
